INCIDENT FACTS

71-229-2022

Forklift Operator's Arm Crushed by Mast

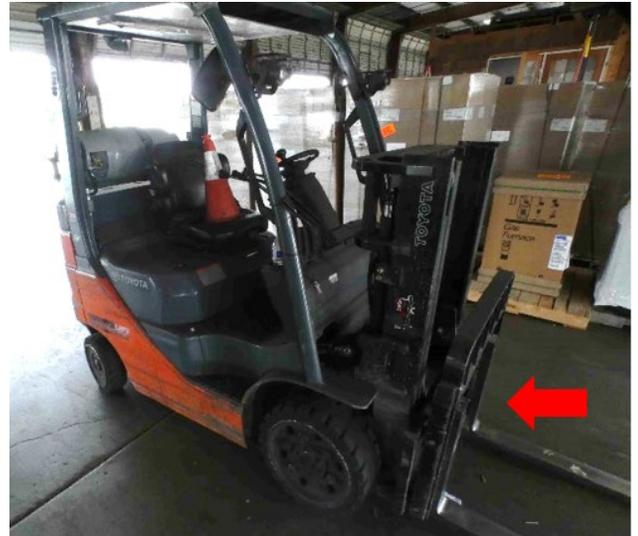
As he leaned, he bumped the mast control lever, causing the mast to drop and crush his arm. The mast's downward motion lifted his body off the driver's seat, which engaged the forklift's automatic shutoff switch and kept his arm caught in the mast. A nearby co-worker climbed on the forklift and sat on the seat to restart it so the operator could be removed. Paramedics treated the operator and transported him to the hospital. The near-death incident severely fractured the operator's arm, which required surgery.

Arrow shows lowered mast on incident forklift. The operator leaned forward in the cab, reached his arm through the mast's crossmembers, and inadvertently engaged the control lever that dropped the mast on his arm, crushing it.

Investigators found that the forklift operator did not follow the employer's Accident Prevention Program (APP) rules and training to never extend any part of their body between the mast of the forklift.

- Install windshield on forklift to prevent operator from reaching arm between mast crossmembers.
- Train forklift operators to:
 - Never place any part of the body between masts.
 - Lower mast to the ground when parking forklift.
 - Understand the hazards of forklift masts.
 - Follow the requirements of the manufacturer's operator's manual.
 - Obey safety requirements on equipment warning labels.
 - Inspect masts and report mechanical deficiencies.
 - Never operate malfunctioning forklifts until repaired.
 - Report hazardous operating conditions and co-worker behavior.
