REPORT #:

71-235-2023

Freight Clerk Crushed by Trailer at Store Loading Dock

SUMMARY

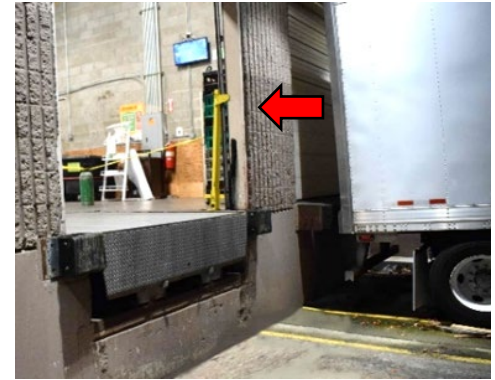
Now alone, the second clerk closed the trailer. A few seconds later, he reopened it, looked in, then walked to the left side and leaned his head and shoulders through a gap between the exterior loading dock wall and rear of the trailer. He then came back in, closed the trailer a second time, and again leaned out the gap between the wall and trailer just as he had done before. At the same time, the truck was preparing to pull forward. When its parking brake was released the trailer lurched back and crushed the clerk against the wall. After the truck pulled away, the first clerk returned to the dock, saw his injured co-worker on the pavement below, and called 911. The clerk died at the scene.

- The employer did not have loading dock safety policies, procedures, and training for workers.
- Workers routinely leaned out between dock walls and trailers to communicate with drivers.
- Trailer was parked away from dock bumpers and on a slight downgrade toward the loading bay.

Arrow shows where the clerk was leaning out when the trailer lurched back and crushed him.

- Construct or modify loading docks to have anti-crush safety zones by installing dock seals, barriers, and/or dock levelers designed to protect workers against vehicle crush hazards.
- Use traffic signal-style vehicle movement indicator lights at loading bays where the truck driver activates a red light to inform warehouse staff when it is safe to open bay doors, and warehouse staff activate a green light to inform the driver when the truck is ready to depart.
- Require truck drivers to check in, leave keys, and wait in a designated safe place inside the shipping and receiving area where workers can talk with them away from hazards.
- Install signage at loading docks to warn workers about area hazards, such as pinch points.
