INCIDENT FACTS

71-248-2023

Owner Crushed Loading Log Skidder on Lowboy Trailer

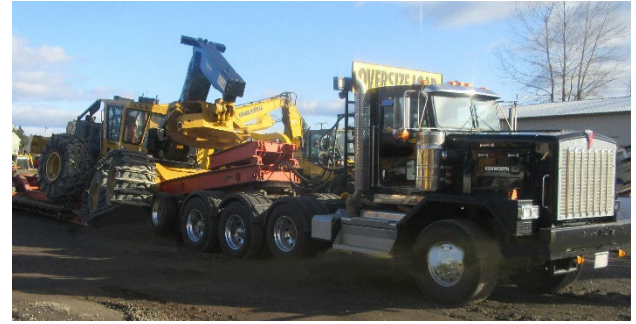
The owner was crushed under the skidder's tracked bogie wheels (X).

An equipment operator who worked for the owner of the skidder drove the machine onto the trailer. The owner and the transporter were on opposite sides of the trailer acting as spotters for the operator. The owner was on the right side 10 to 20 feet away from the skidder. The skidder ended up with its bogie wheels uneven between the trailer's lowered flatbed deck and detached gooseneck. As the operator tried to adjust the wheels, he inadvertently turned on the maximum speed switch on the joystick. He then activated the travel trigger, which made the skidder lurch back 9.5 feet partly off the deck into the gooseneck. For an unknown reason, the owner walked behind the skidder when it moved. When the operator and transporter did not see the owner, they went around the trailer and found him crushed and gasping under the skidder's left tracked bogie wheels. First responders pronounced the owner dead at the scene.

Semi-truck with skidder on lowboy trailer after incident.

- Never allow heavy equipment operators to load or unload any machine on a trailer unless they have been properly trained, evaluated, and certified to operate the machine.

- Train spotters how to identify and stay out of vehicle blind areas, remain visible to operators, approach vehicles, avoid distractions, and keep a safe distance between themselves and moving vehicles.

- Make sure operator and spotter pre-plan vehicle movements and agree on hand signals before loading or unloading equipment on trailer. Designate one spotter to communicate with operator to avoid confusion. If visual contact is lost with the spotter, the operator must stop immediately.
